BLUEBONNET REAL ESTATE INSPECTION SERVICE

PROPERTY INSPECTION REPORT

Concerning: 5302 FM 50, Brenham, TX 77833
 (Address or Other Identification of Inspected Property)

By: Kevin M Ullrich, Lic #965 02/09/2016
 (Name and License Number of Inspector) (Date)

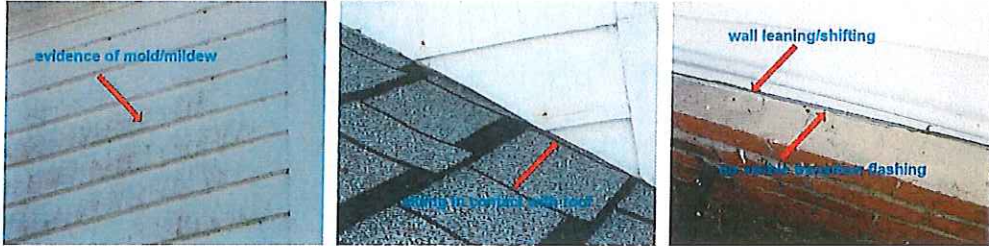
Comments: Exterior Finish: wood siding, brick/stone veneer
 Evidence of mold/mildew in exterior siding/soffit/trim/brick/stone areas on all sides. Siding in contact with the roof on all sides. Current requirements suggest siding be at least 1" above roofing materials. There is no visible transition flashing installed at siding/masonry connection areas on left side, etc. Brick skirting wall appears to be leaning/shifting away from house on front, left side, etc.

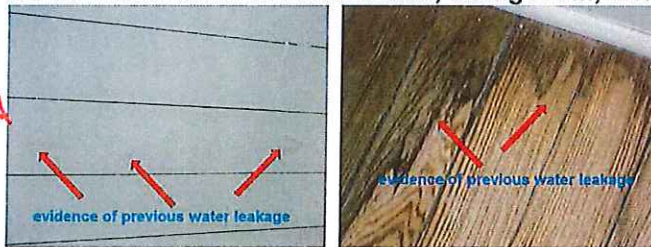
Comments: Ceiling has evidence of previous water leakage/damage in kitchen, den, etc. Floors sloping/un-even throughout house. Evidence of previous water leakage/damage noted in floor areas of lower H-bath, dining room, etc.

This is the wood pattern NOT water stains

From many years ago before current seller.

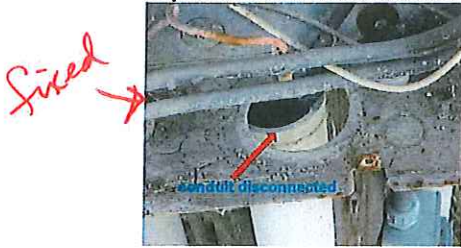
Comments: Wires entering panel box(es) missing clamp/bushing(s) to protect wire from damage when entering the box. Conduit disconnected from panel box. There is no visible grounding electrode system installed for this property. Current standards require us to report as deficient the lack of a grounding electrode system.

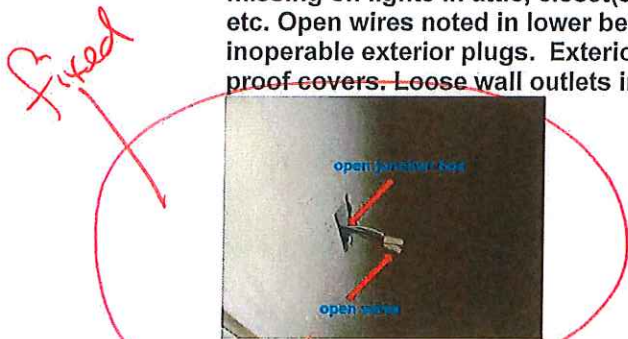
Comments: The house is not meeting current standards for smoke alarm installation. The current standards require a smoke alarm in every bedroom, one smoke alarm outside each sleeping area, and a smoke alarm on each floor level of the house. All of these smoke alarms are required to be interconnected, meaning if one goes off, all the alarms go off. All plugs are not GFCI protected in kitchen countertop surface areas. There is no visible 4-prong 220 plug installed in laundry room for electric dryer use. Dimmer switch not 3-way in dining room. Dimmer switch not performing a dimming function kitchen. Bulb protectors missing on lights in attic, closet(s). Open junction boxes noted in lower bedroom closet, etc. Open wires noted in lower bedroom closet, etc. GFCI (ground fault circuit interrupter) inoperable exterior plugs. Exterior outlets on all sides do not have "in use type" weather-proof covers. Loose wall outlets in exterior plugs.

But these by water are GFCI

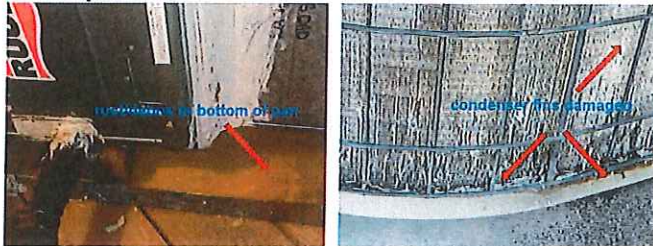
Comments: Temperature Differential: L-20, U-20, MBR-19

The air conditioning systems are more than 10 yrs old. They will require a higher level of maintenance, and may be more prone to major component breakdown. Predicting the frequency or time frame for repairs on any mechanical device is virtually impossible. If the compressor fails, or if breakdowns become chronic, replacing the entire system may be more cost-effective than continuing to undertake repairs. **Rust/debris in bottom of back-up drain pan(s) in attic under A/C unit(s). Significant damage noted to lower unit condenser fins. Further investigation and repairs needed.**
